The Results of the T-45 Main Landing Gear Uplock Investigation and the Effect that Organization Structure Had on Them

Christina Marie Stack

A Thesis
Presented for the
Master of Science Degree
The University of Tennessee, Knoxville

Christina Marie Stack
August 2004

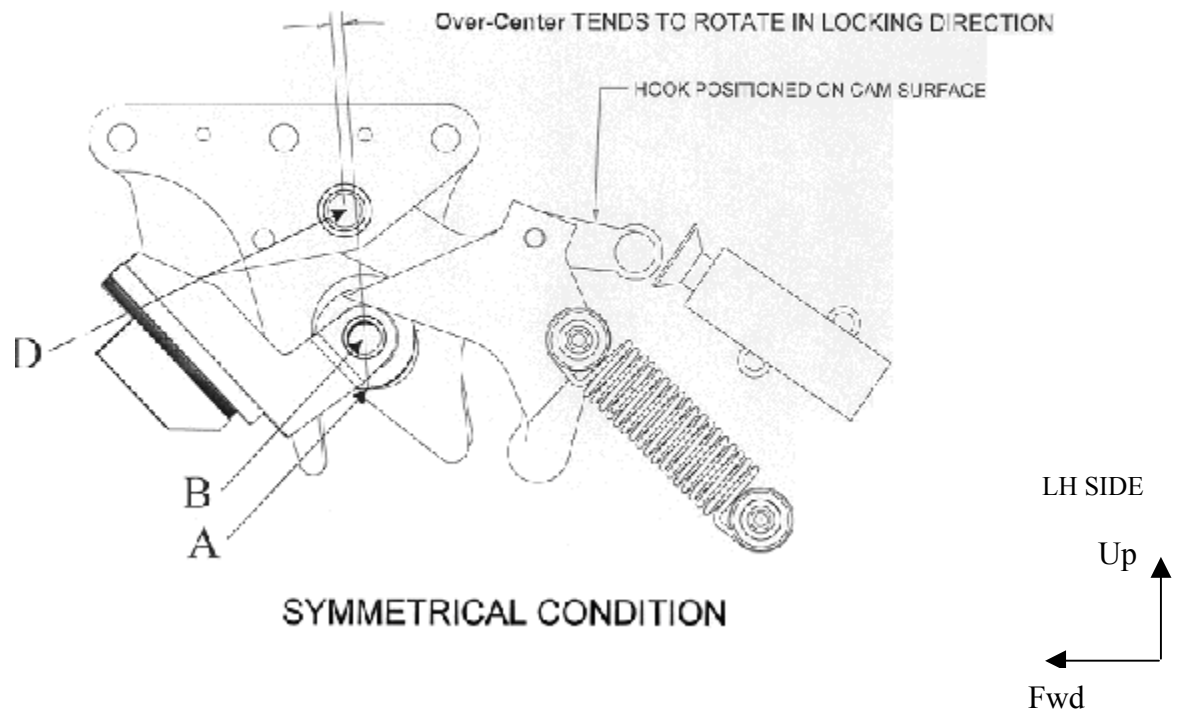
Figure 1: MAIN LANDING GEAR UPLOCK OVER-CENTER DISTANCE

roller to push the latch open and allow the gear to fall onto the gear door during wing deflection conditions. A Boeing engineering finite element model was used to predict wing deflections. A tolerance survey of the uplock components, which included allowances for the interference due to wing deflection, determined that each mishap aircraft had a positive 0.85mm over-center distance.

MLG stowed, load line is measured as the line formed from connecting the contact point of the roller on the hook (A) through the center of the roller (B). Over-center dimension is calculated by taking that load line and measuring the distance from the center of the hook latch pivot point (D).

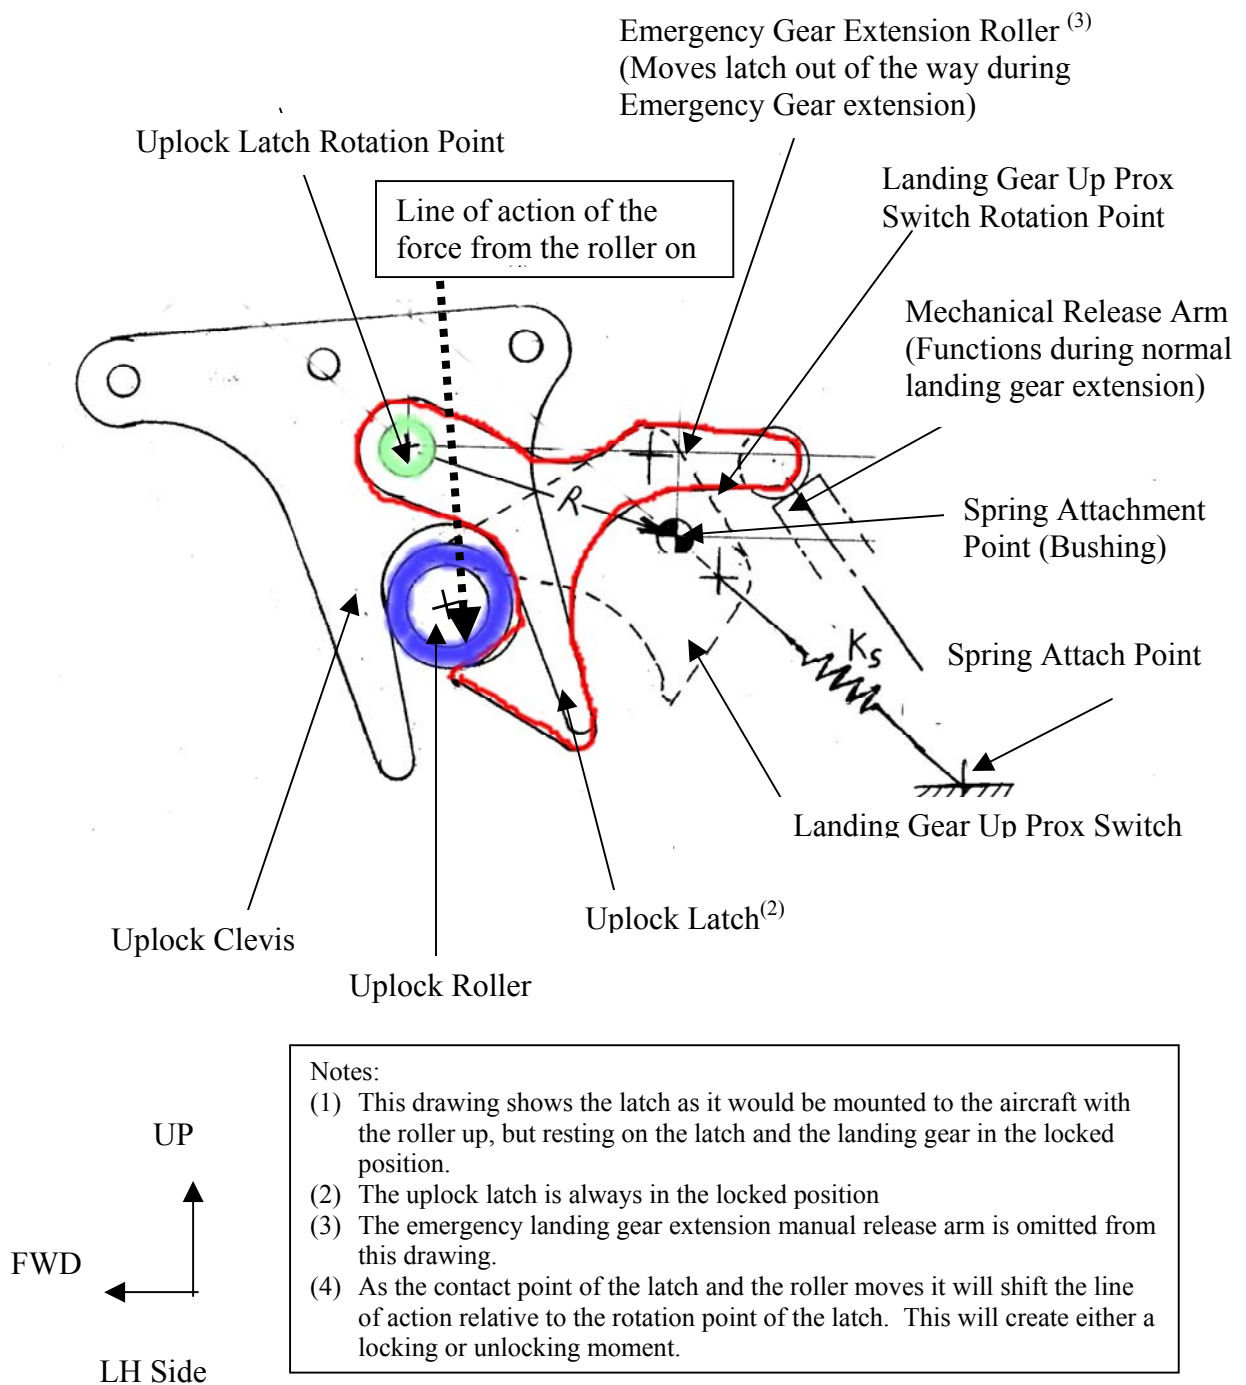
Figure 2: MAIN LANDING GEAR UPLOCK MECHANISM
(UNINSTALLED FROM AIRCRAFT)

wall of the spring pin structural slot (see Figures 2 and 3, Appendix A) to push the spring pin upward. This interference causes the uplock latch to rotate in the unlocking direction while the roller simultaneously overcomes the actuator force and rests on the latch. Design and assembly tolerances allow for this condition. In this situation, significant interference could allow the latch to fully open and allow the gear to extend under high g conditions when the weight of the gear overpowers the retract actuator resulting in the gear extending at high g and high-speed conditions.

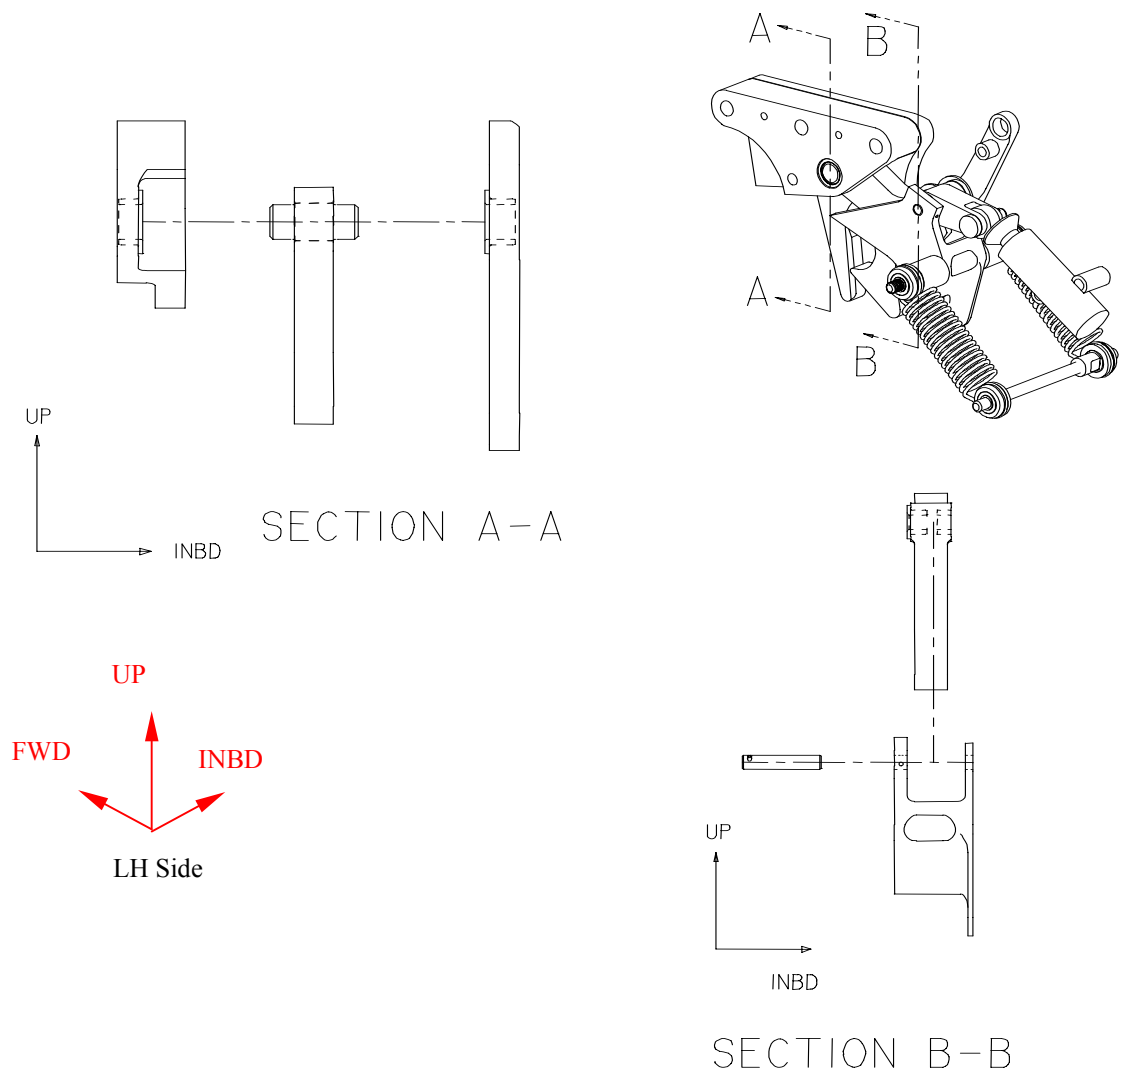
Figure 14: TARGET LINK ASSEMBLY

components to meet the free-fall requirements. The target link assemblies were found to be a contributory factor to the overall friction in the uplock mechanism. AFC 267 and AFC 267 Amendment 1 were not acceptable as written because they did not address the additional friction in the uplock mechanism due to the target link assembly bushing. The target link bushing procedures were added to AFC267 Revision A. It was recommended to add a time interval inspection of the system to ensure that excessive friction is discovered and promptly corrected, however, this recommendation has not been accepted by the NADEP at this time. Since the target link assembly bushings were cleaned and replaced, and the free fall requirements were met, the uplocks for the rest of the test will be referred to as AFC 267 with representative revision A incorporated for the remainder of this document.

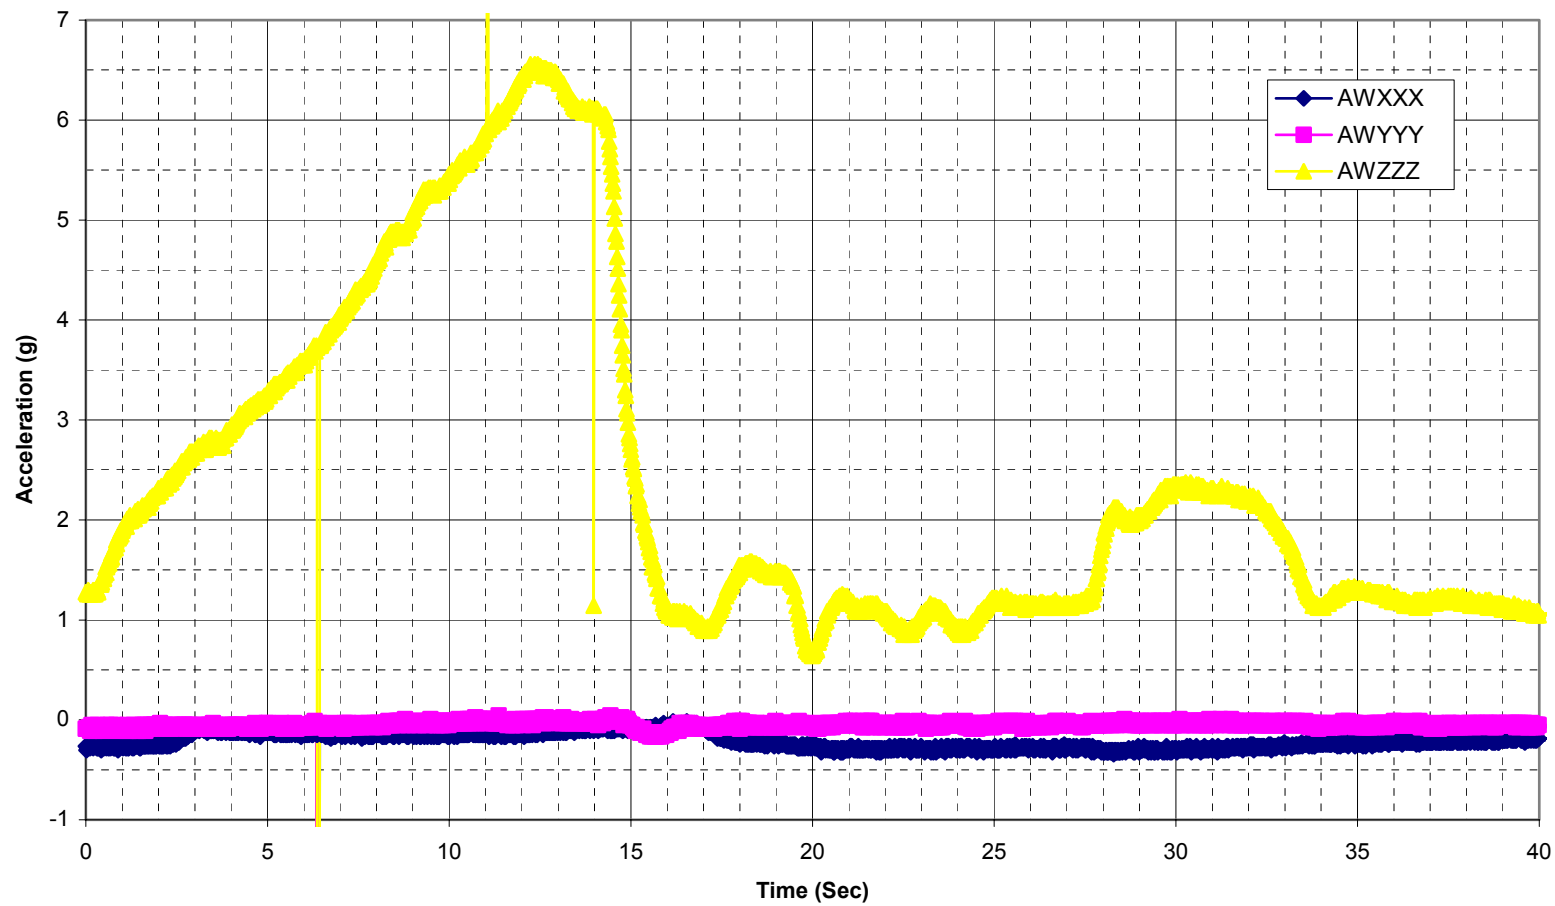
Figure 17: WING ACCELERATION VALUES DURING POINT WITH SPRING MOTION (TP2-19, FLT 1620)

next test point, 11,000 ft, 6.5g and 0.72 M, slight motion on the spring was noticed in the direction to open the latch. The g levels achieved on the 6.5g point in all three axes on the wing and the landing gear accelerometers are depicted in Figure 17 and 18 (Appendix A), respectively. Even with the motion of the spring no motion of the latch appeared. On a subsequent test point targeting a higher Mach number point, only 6.2 g was achieved. No motion of the latch or the spring was observed. No further points were repeated as a safety precaution. Without AFC 266 installed, slight motion is evident in the spring in the direction of opening the latch. When combined with a small over-center distance this could pose as a potential cause for the inadvertent landing gear extensions.

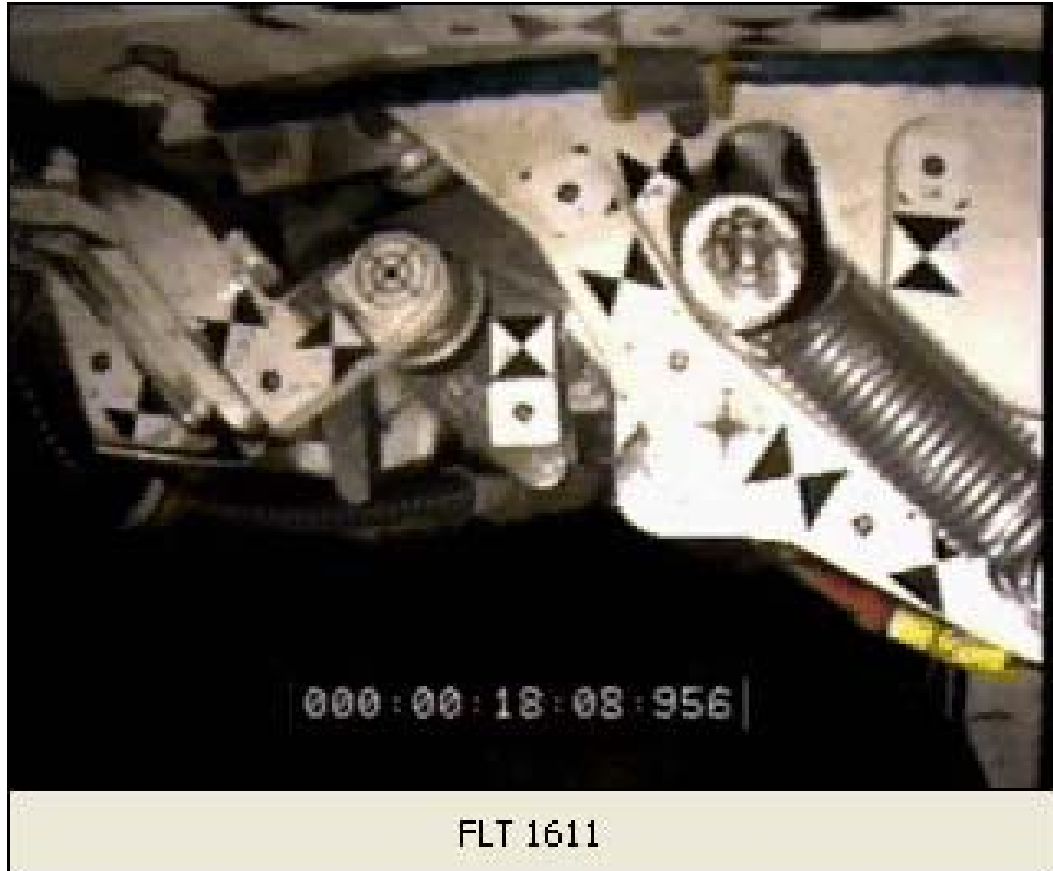
Figure 21: FLT 1611 HYDRAULIC PRESSURE CHANGES
(Note1: Double click to play video)
(Note 2: Time stamp is incorrect on video)

simulate a failed intermittent WOW switch. During the test, no tendency for the roller to fall past the latch was observed. A video clip of test point 4-2, from flight 1611 is included as Figure 21 (Appendix A). When the gear is in the up and locked position, the lock pressure is maintained at approximately 3000 psi, Figure 22 (Appendix A). When the switch was toggled, the largest pressure that was observed in the unlock actuator lines was less than 450 psi, Figure 23 (Appendix A), during test point 4-6 of Table 4 (Appendix C.) The lack of large pressures in the unlock line indicates that the pressure is inadequate to physically open the latch. During normal operation, approximately 2900 psi is provided to the actuator to open the latch, Figure 24 (Appendix A). The hydraulic pressure spike that occurs in the unlock line during a simulated intermittent WOW proximity switch is significantly smaller than pressure that occurs to open the latch for a normal gear extension. With AFC 266 and 267 revision A an intermittent WOW switch was not considered a contributing factor for inadvertent landing gear extensions.

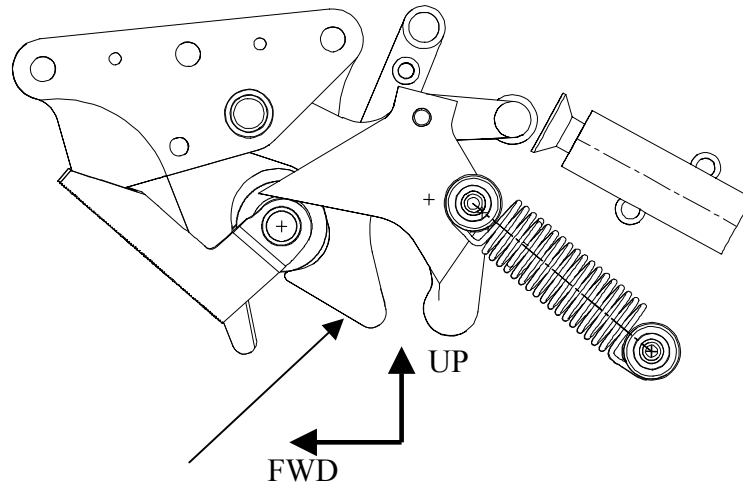
Also checked to see the force required to move just the hook and target link with the force gauge applied flat to the lower tip surface as shown below: 1 lb initial breakout force on both sides
